I-39/90/94 Route Importance

Purpose and Need

The purpose of the I-39/90/94 Wisconsin River Bridge Project is to address the needs of the aging I-39/90/94 structures and maintain vehicular traffic across the Wisconsin River in the towns of Dekorra and Caledonia located in Columbia County.

Wisconsin River Bridge Condition is Deteriorating

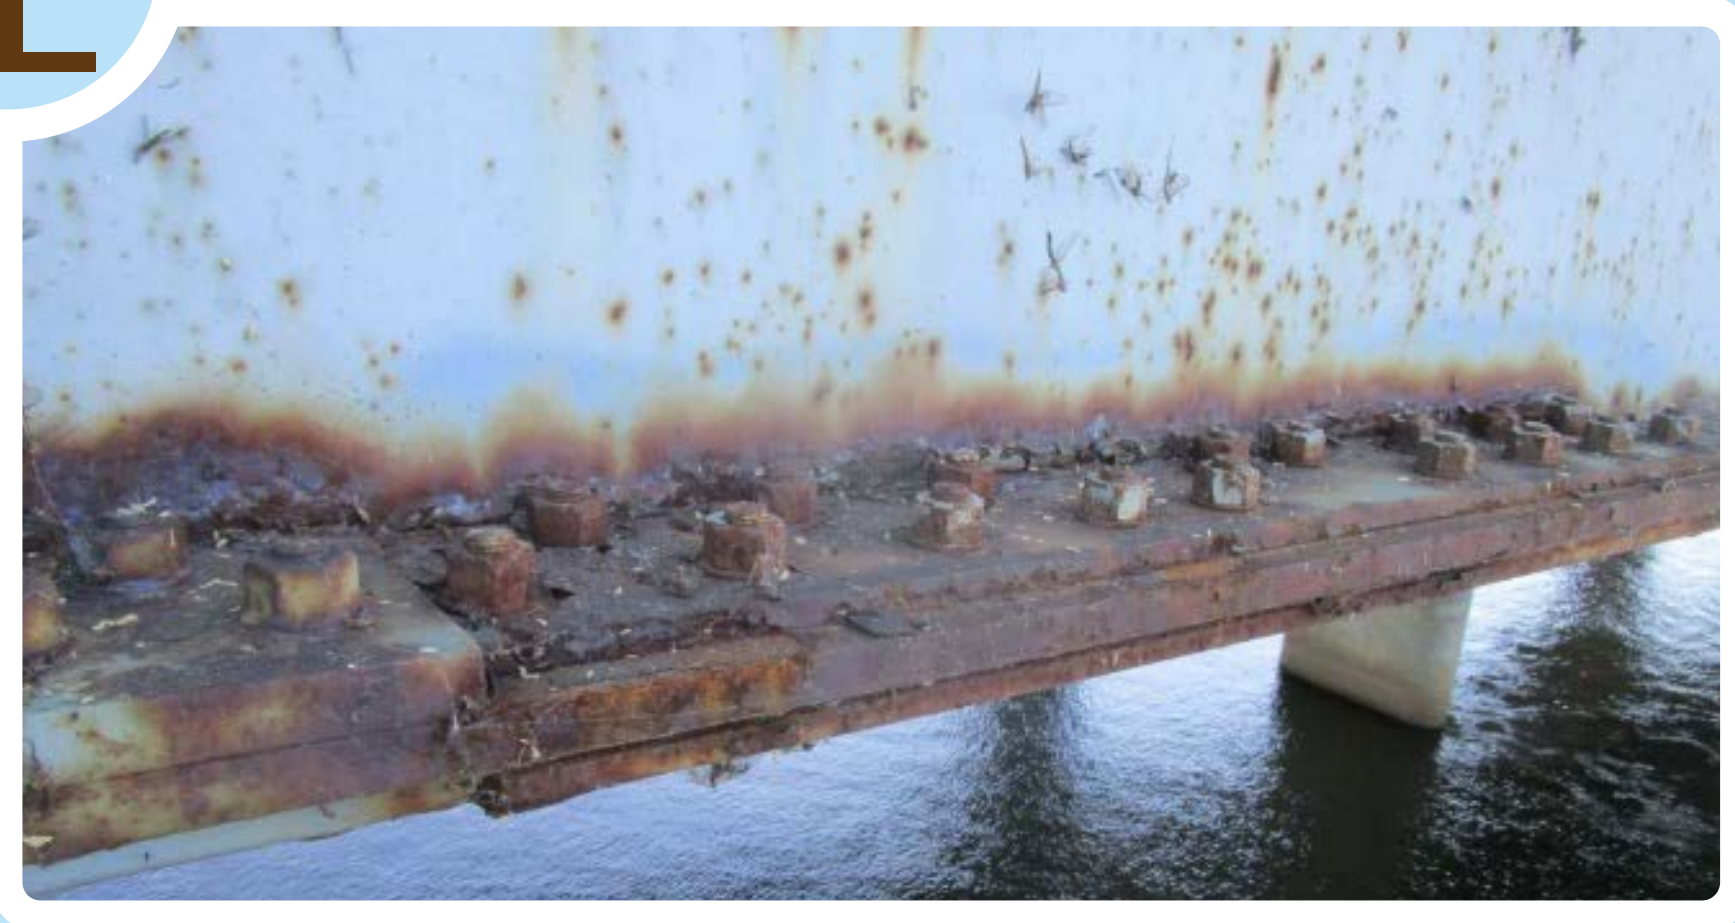
Severe condition

Loss of protective coating over steel elements and connections.

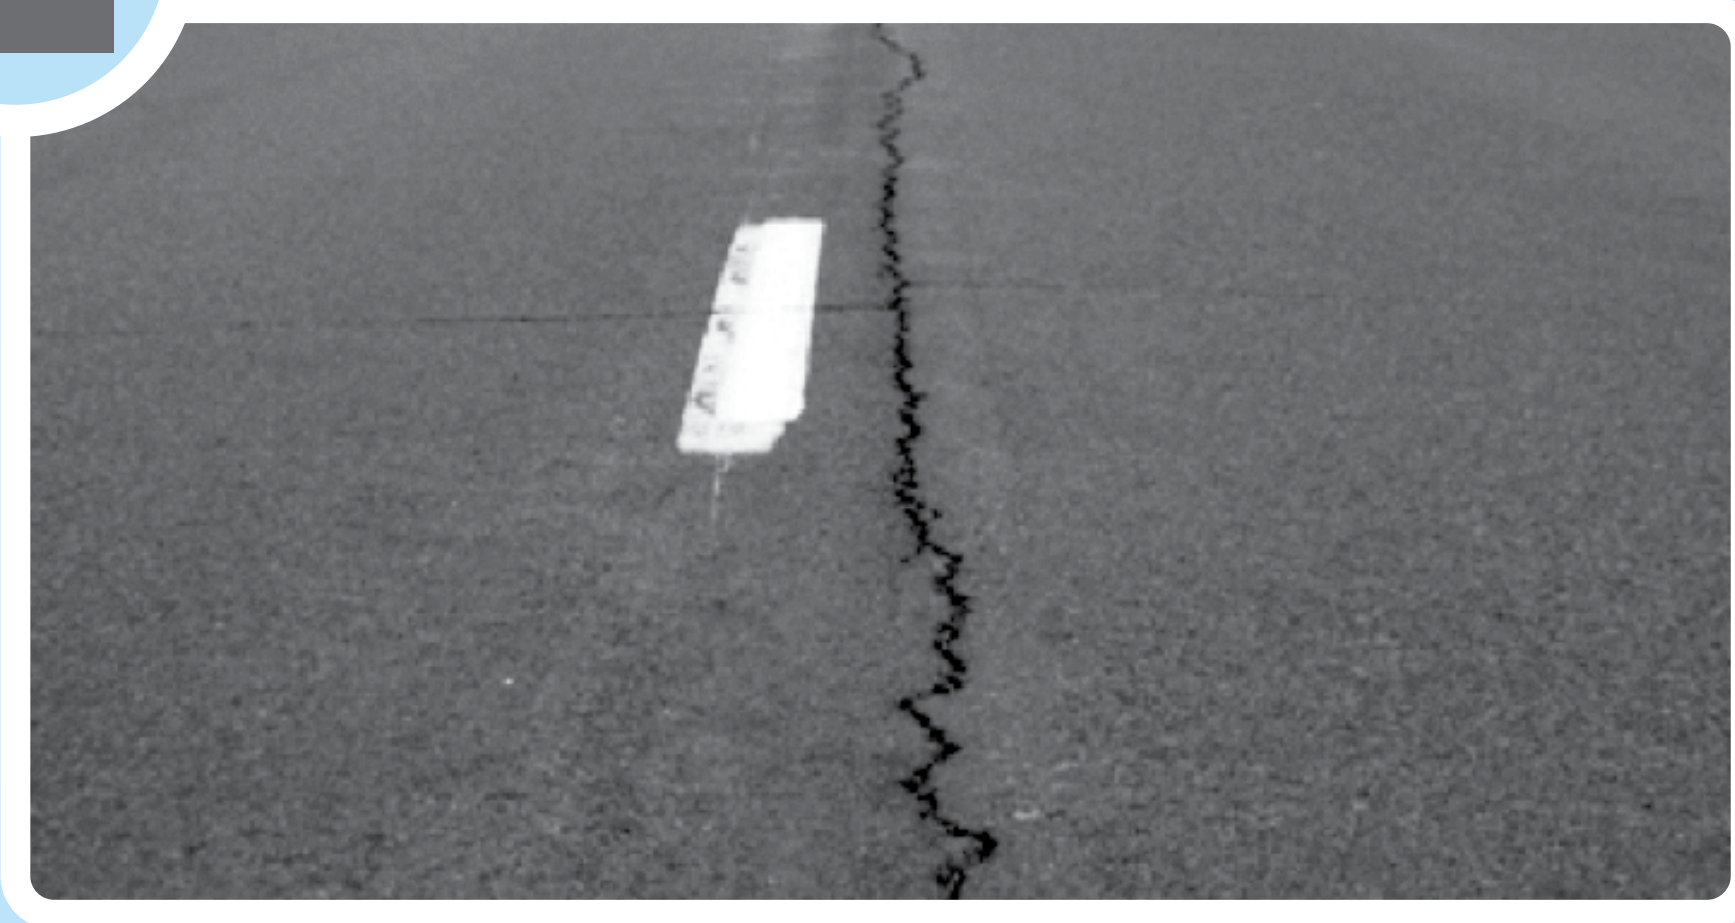
Poor condition

Cracking of the asphalt overlay causes deterioration of the bridge deck.

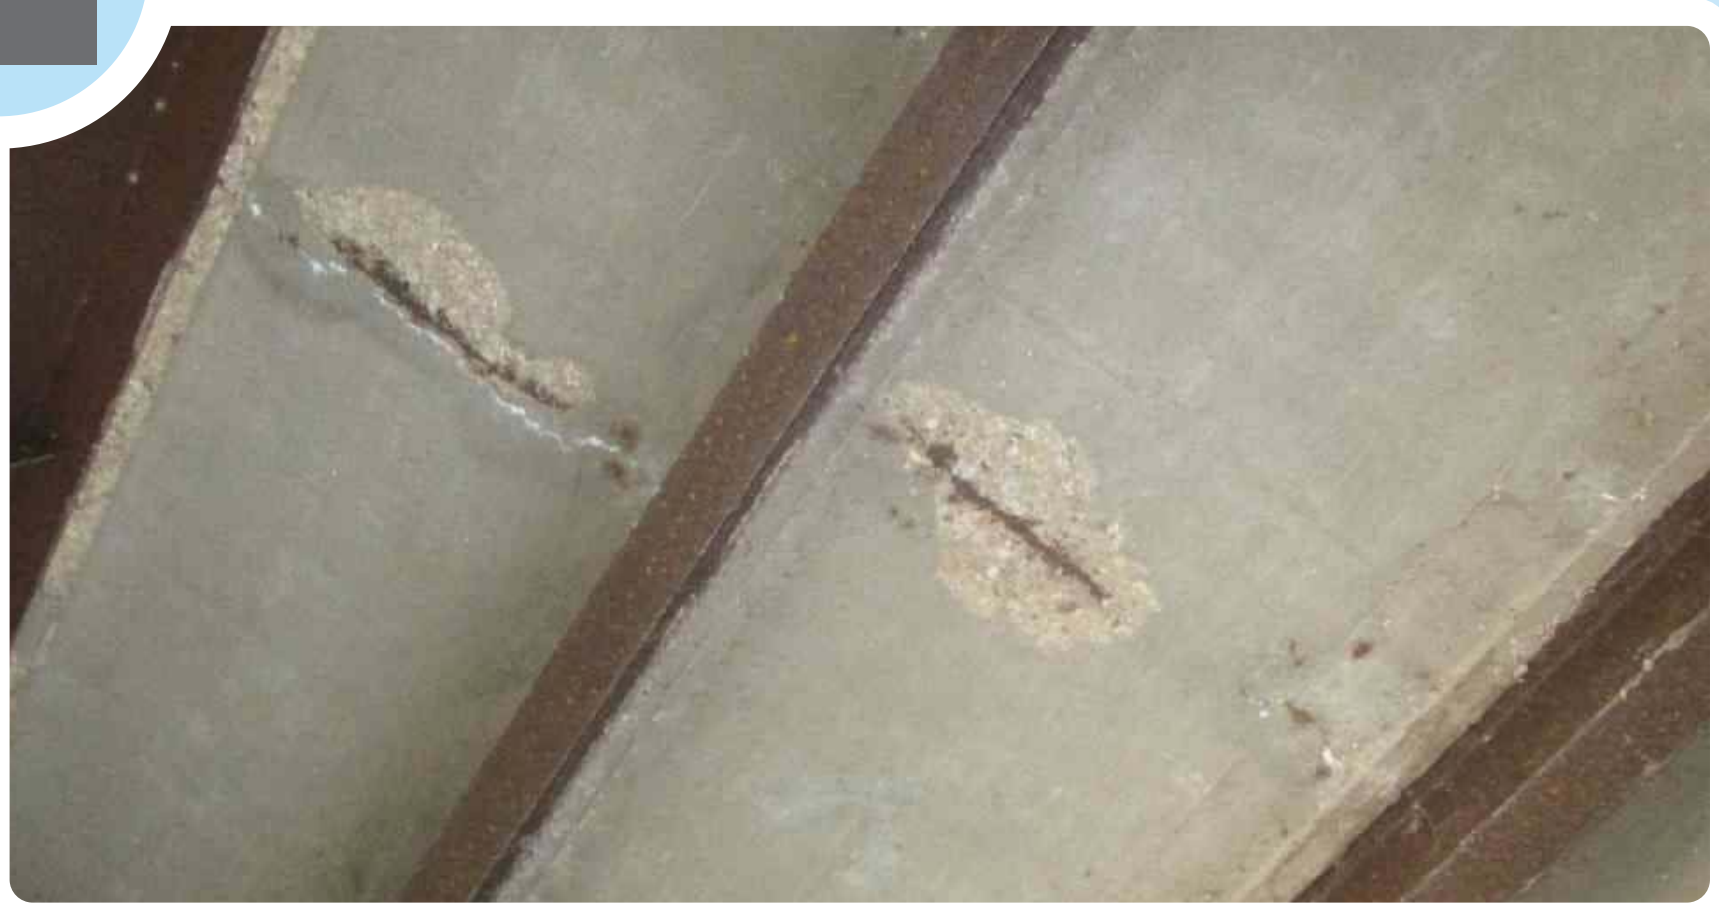
Poor condition

Concrete on the bottom of the bridge deck is cracking and chipping off, exposing the reinforcing steel.

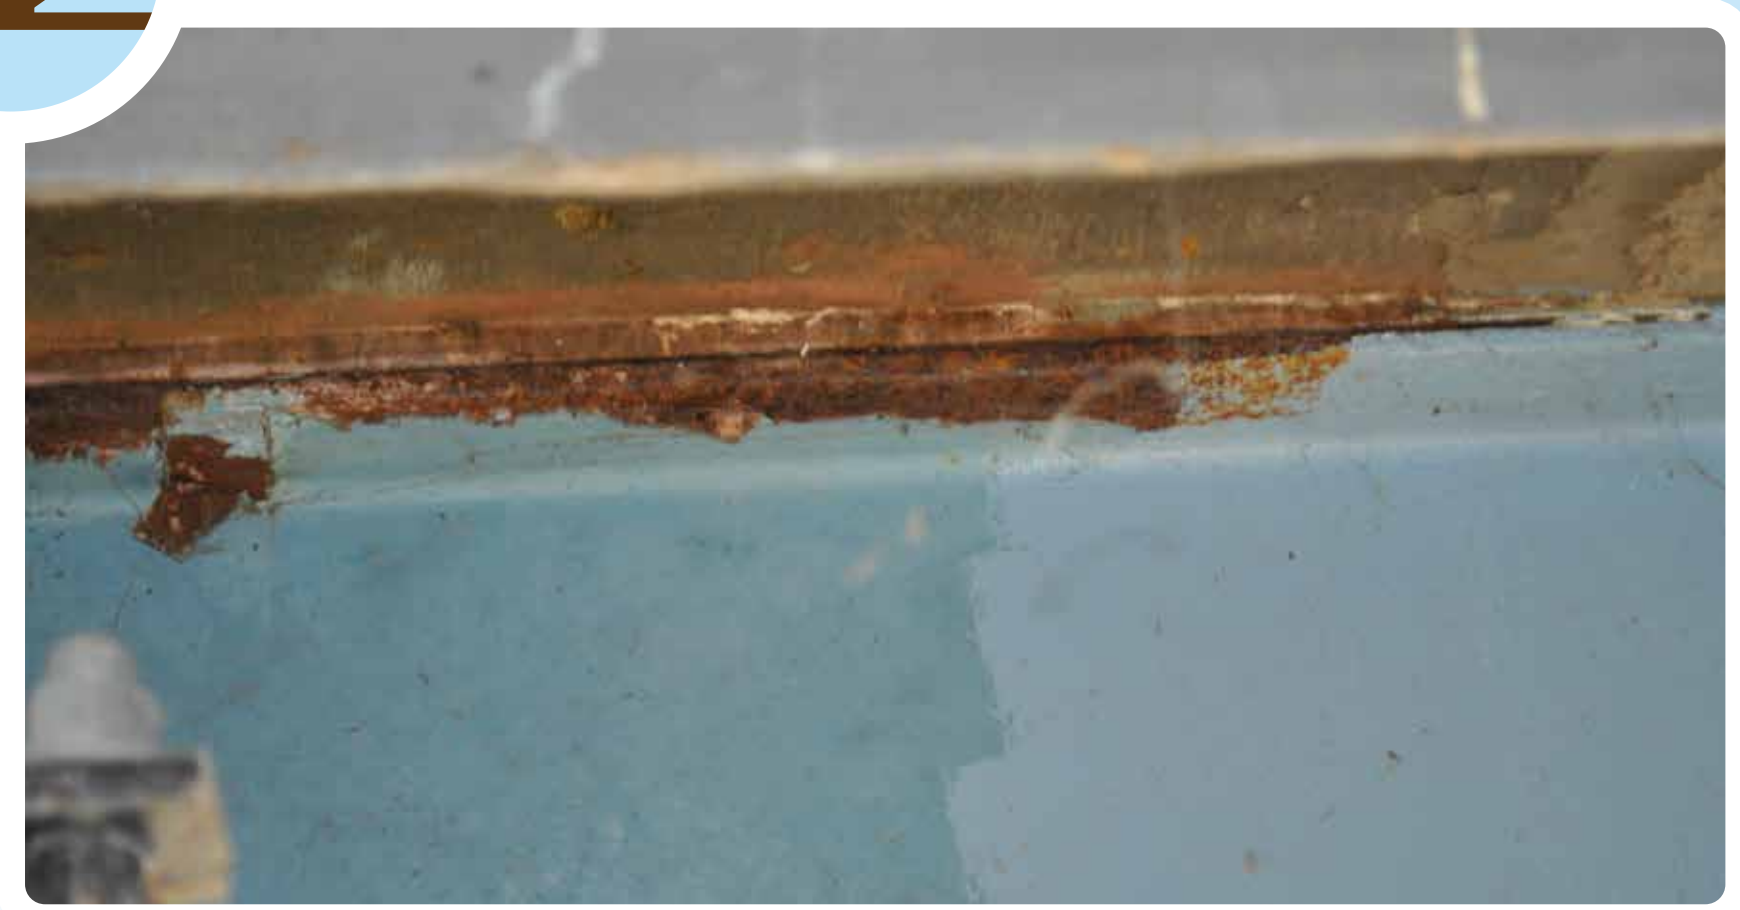
Poor condition

Pack rust has formed between steel elements causing bulging and distortion, leading to added stress and cracking in the concrete deck.

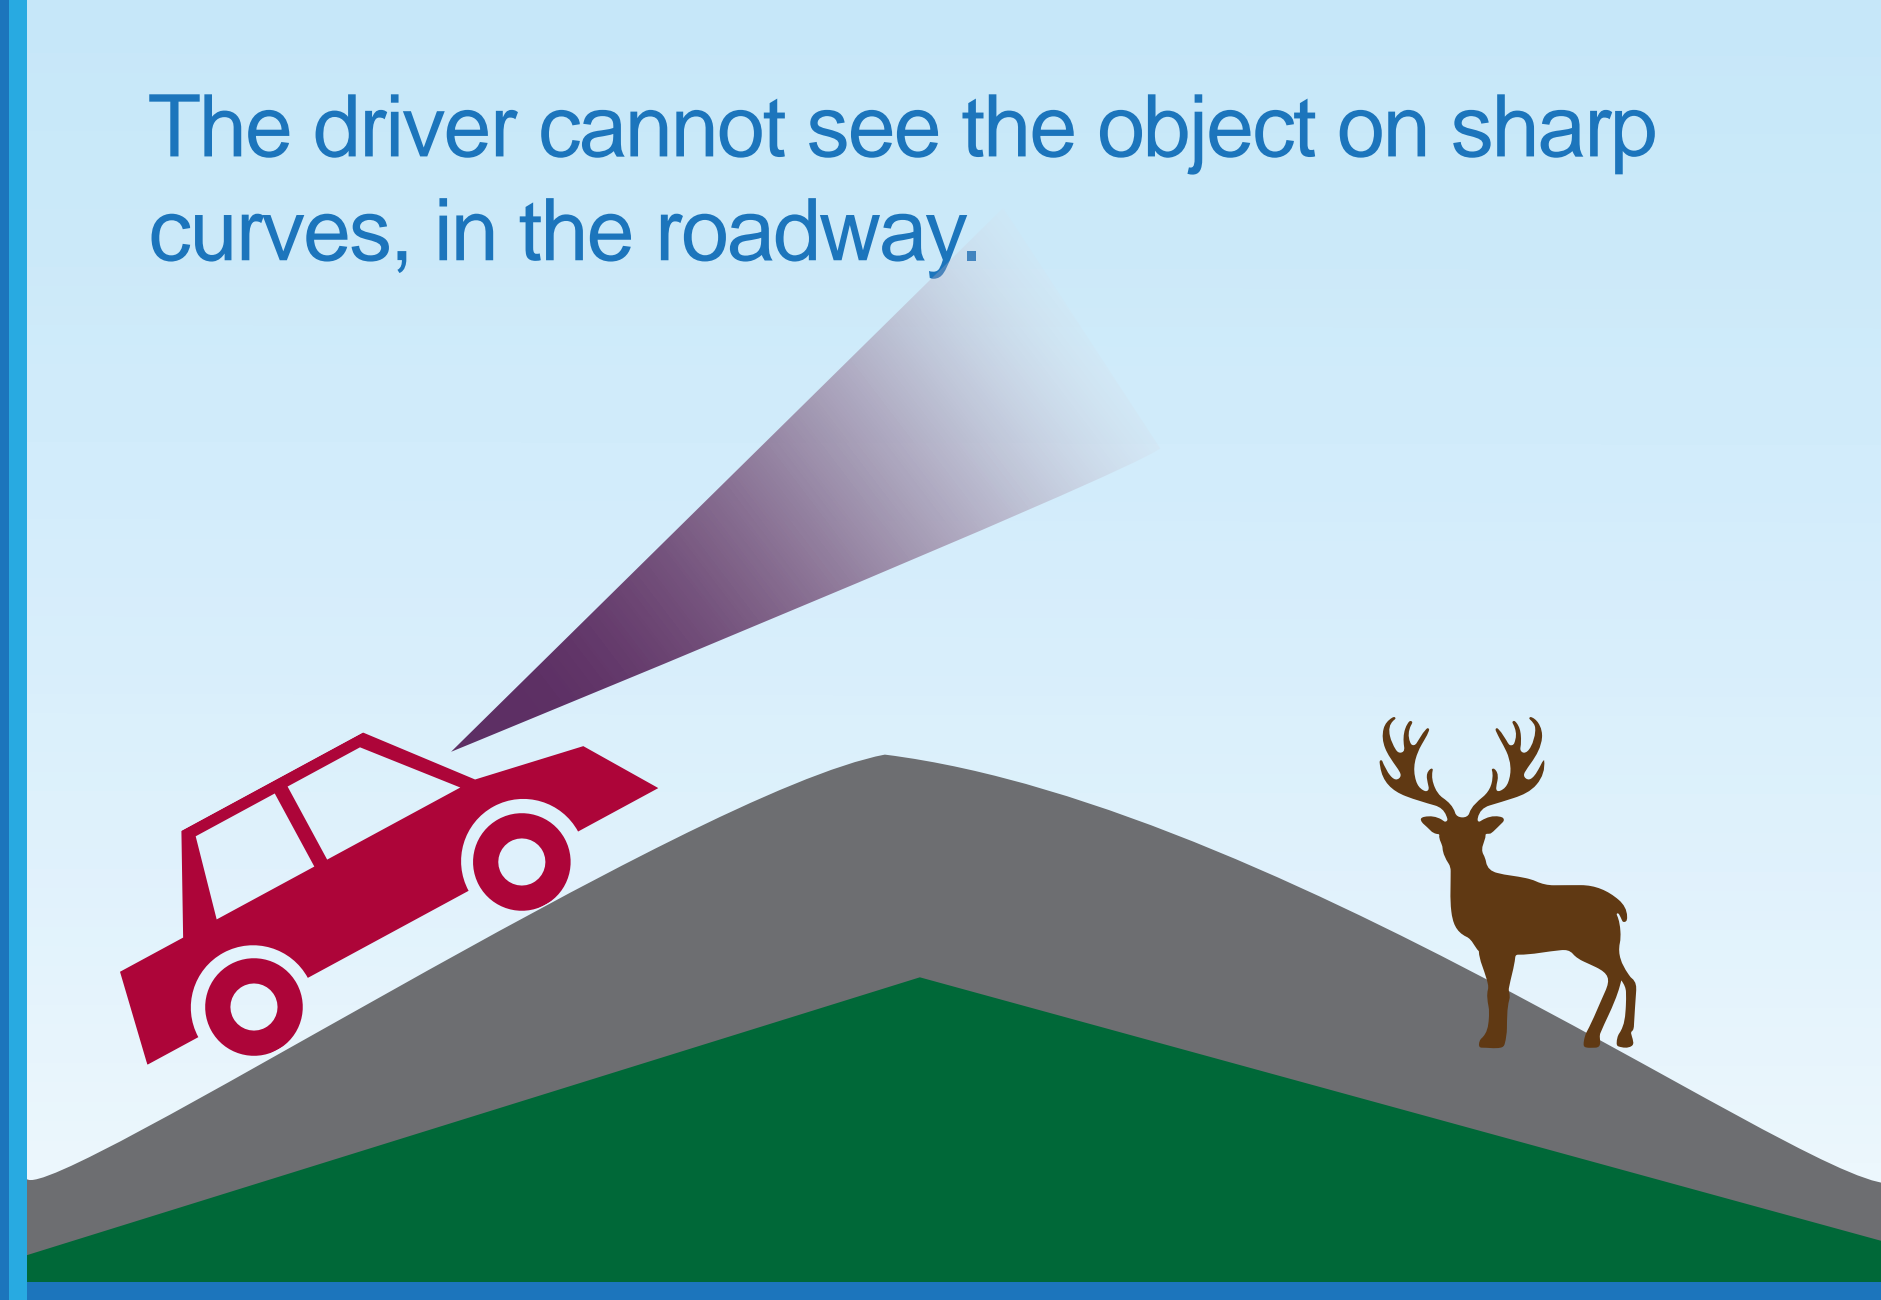
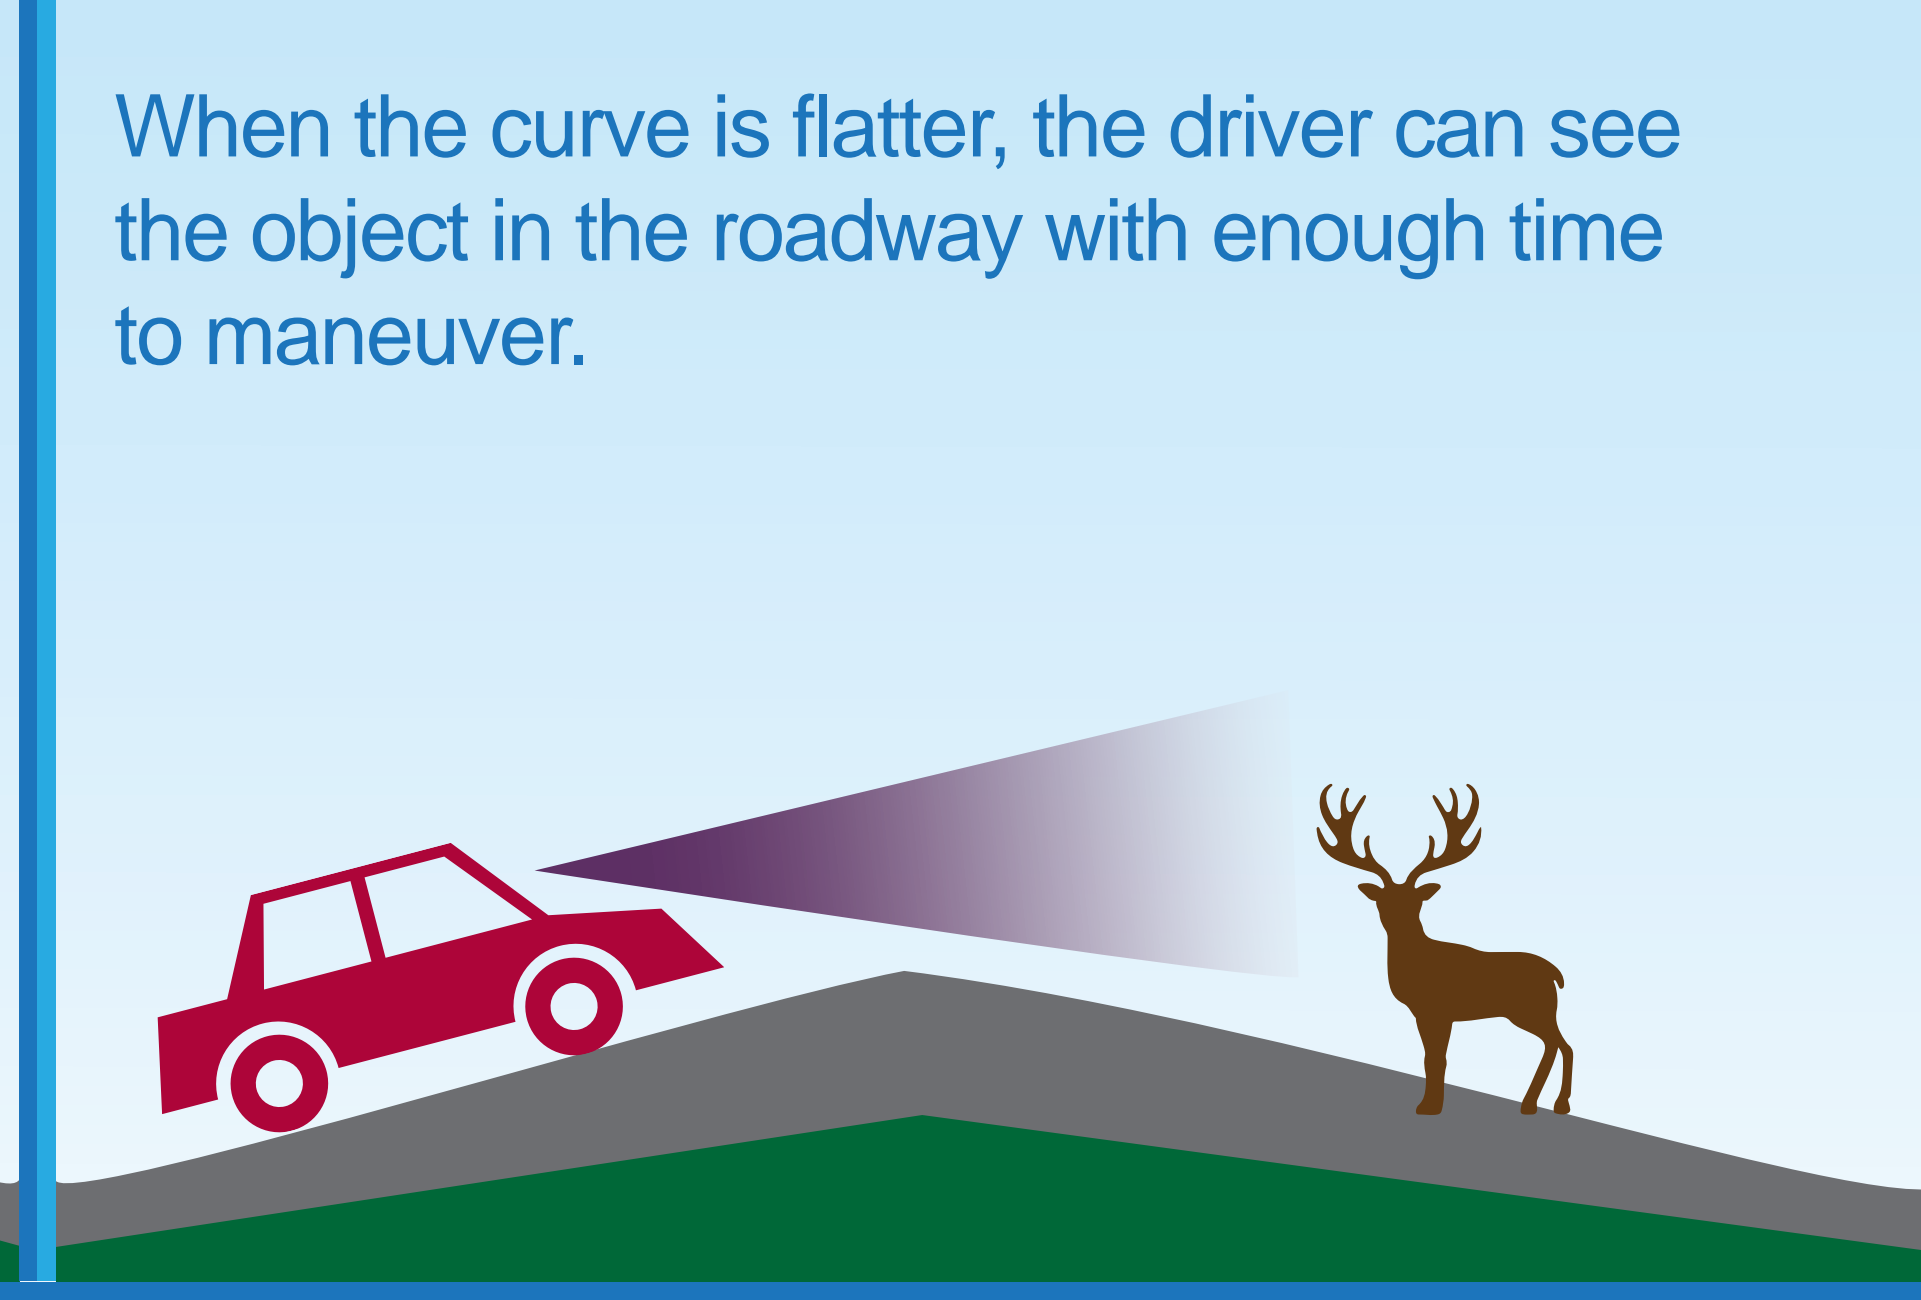
Decision Sight Distance
Decision sight distance is needed for a driver to:
(1) detect a condition in a roadway and recognize its threat
(2) select and complete appropriate avoidance maneuver

Three I-39/90/94 vertical curves in the project area do not meet decision sight distance standards
